# TECH • INFO

## IP-65 Ingress Protection: How to Handle A720 & A733 RTUs

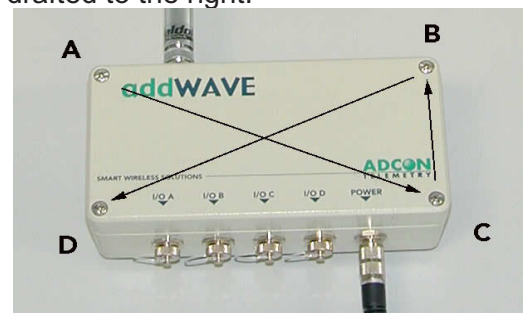
More recently we have isolated a number of instances when leaks have occurred into the A720/A733 case. The primary cause of these problems was the improper replacement of the enclosure’s cover. If the cover was opened and either:

- a) the lid was attached to the bottom part of the box first and tightened unevenly, or
- b) the lid was replaced with dirt or other material between slot and key,

then the integrated gasket can not seal properly and the internal components may become exposed under extreme conditions.

- gently clean the rubber seal with a soft, damp cloth (water only! no chemicals please!)
- clean the key on the top of the lower part of the case to remove dirt or obstructions
- carefully replace the lid onto the case matching the slot/key (this is done best with the addWAVE flat on a steady surface)
- it is strongly recommended to lubricate the thread of the top screws prior to closing the case to enhance the sealing process. The lubricant best suited for lubrication is graphic machine oil.
- tighten the bolts using the following procedure as drafted to the right:

SLIGHTLY fasten bolts A > C > B > D. Check the gap between lid and box to be fairly even. In a second round tighten again in the same order, A > C > B > D. Do not tighten the screws too tight as this may cause damage to either the seal or the thread. Ideally use a torque screwdriver to tighten the screws to a value of 200Nm.
